2019 Data Report for Lower Hamlin Lake, Mason County

Site ID: 530073

Lower Hamlin Lake, Mason County 2019 CLMP Results

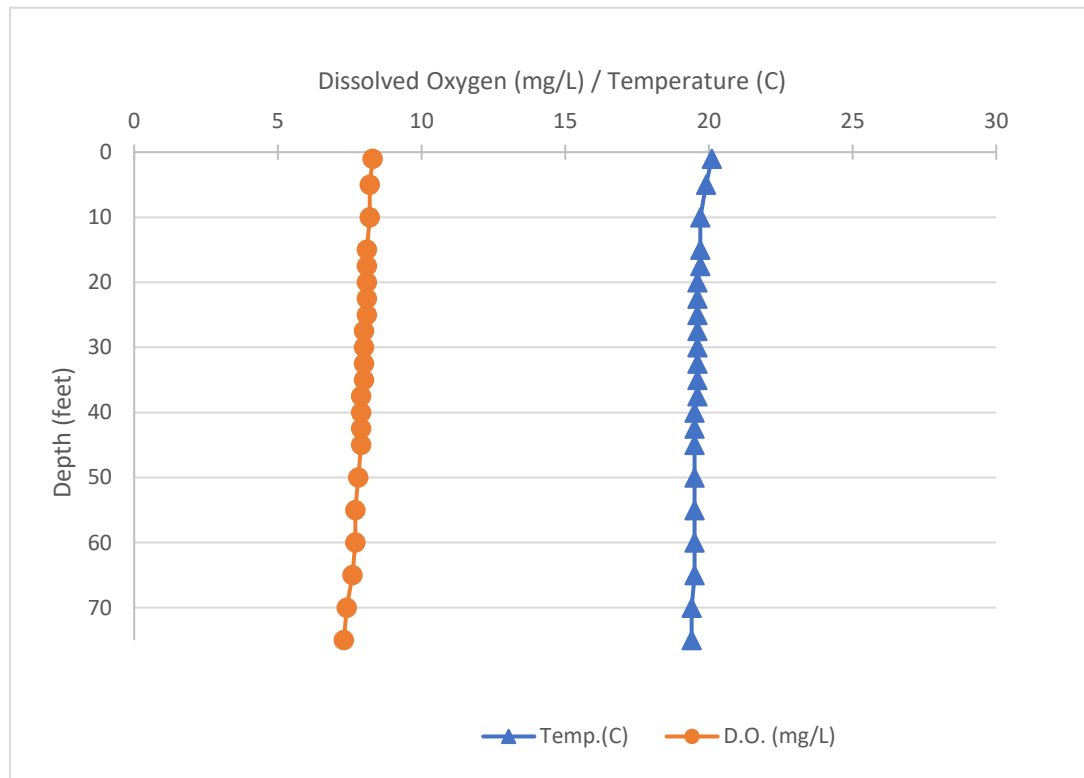
9/17/2019

Dissolved Oxygen and Temperature Profile
