Cooperative Lakes Monitoring Program

2015 Data Report for Lower Hamlin Lake, Mason County

Site ID: 530073

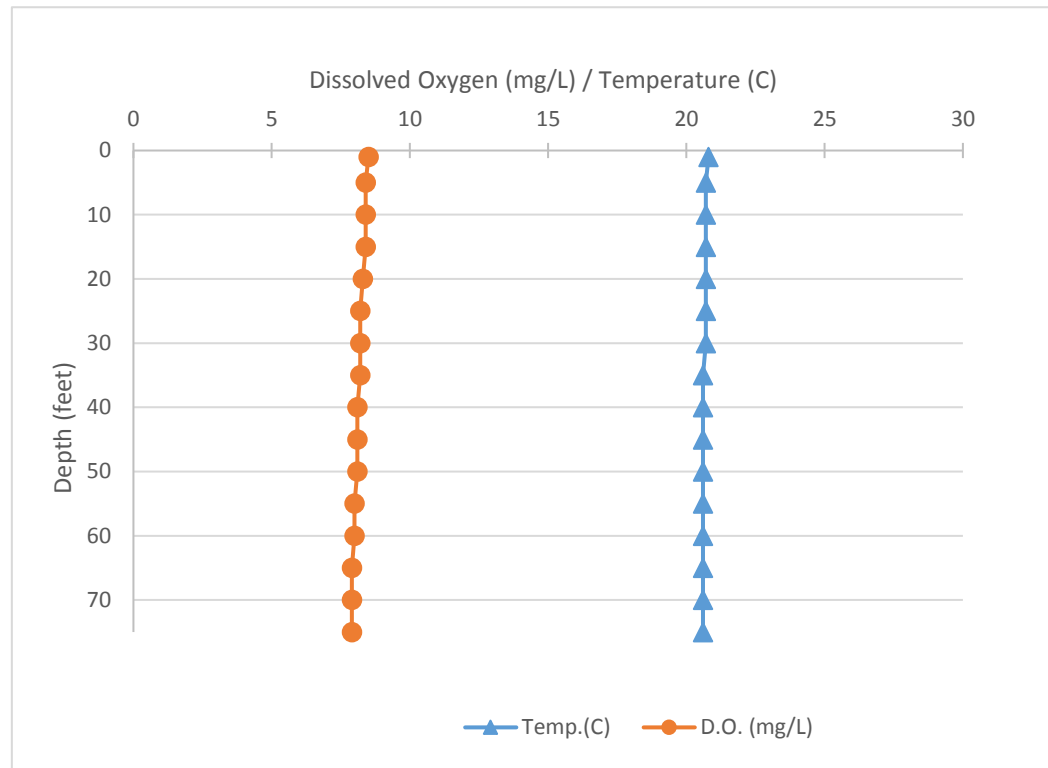
Dissolved Oxygen and Temperature Profile

Depth (ft)	Temp.(C)	D.O. (mg/L)
1	20.8	8.5
5	20.7	8.4
10	20.7	8.4
15	20.7	8.4
20	20.7	8.3
25	20.7	8.2
30	20.7	8.2
35	20.6	8.2
40	20.6	8.1
45	20.6	8.1
50	20.6	8.1
55	20.6	8
60	20.6	8
65	20.6	7.9
70	20.6	7.9
75	20.6	7.9
